CONDITION SURVEY, ALTUS AIR FORCE BASE, OKLAHOMA

R. D. Jackson

April 1973

Conducted by U. S. Army Engineer Waterways Experiment Station
Soils and Pavements Laboratory
Vicksburg, Mississippi

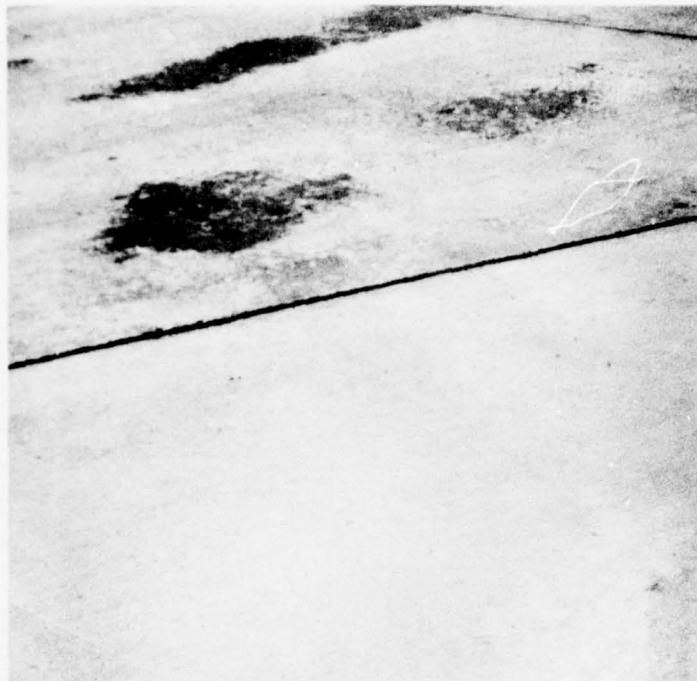
Photo 1. Scaling due to jet engine blast;
south end of taxiway 5

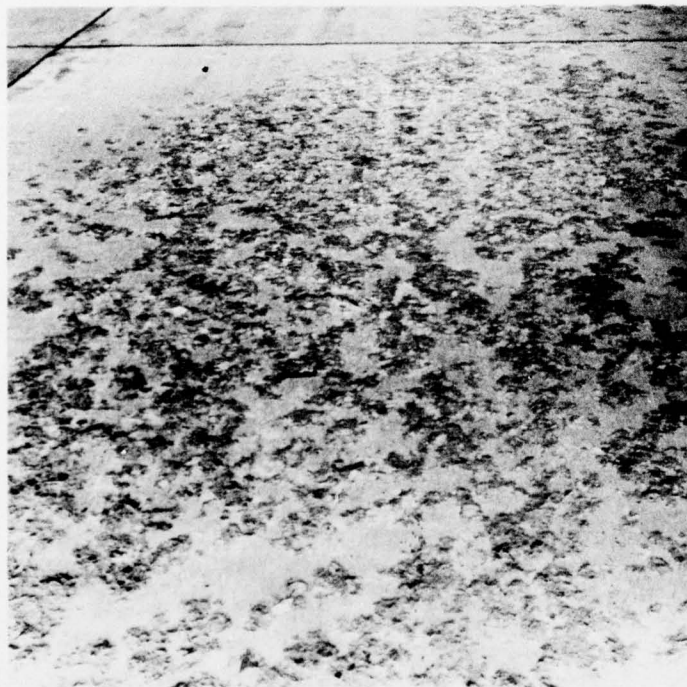
bonded PCC overlays, 1 to 3 in. thick, were applied to 24 slabs in the center apron (feature A4B) in 1962 to repair damage caused by a fire. Photo 2 shows the condition of one of the fire-damaged slabs. Most of the overlays contained small shrinkage cracks (see photos 3 and 4), and some were not completely bonded to the underlying slabs. The north warm-up apron (feature A12B) had only 5 slabs containing major defects, and its condition was rated as excellent. In 1965, 17 slabs were replaced in the north warm-up apron. The operational apron had 38 slabs replaced in 1965. It is reasonable to assume that this slab replacement was required because of channelized traffic.

Photo 2. Fire-damaged slab in center wing
parking apron

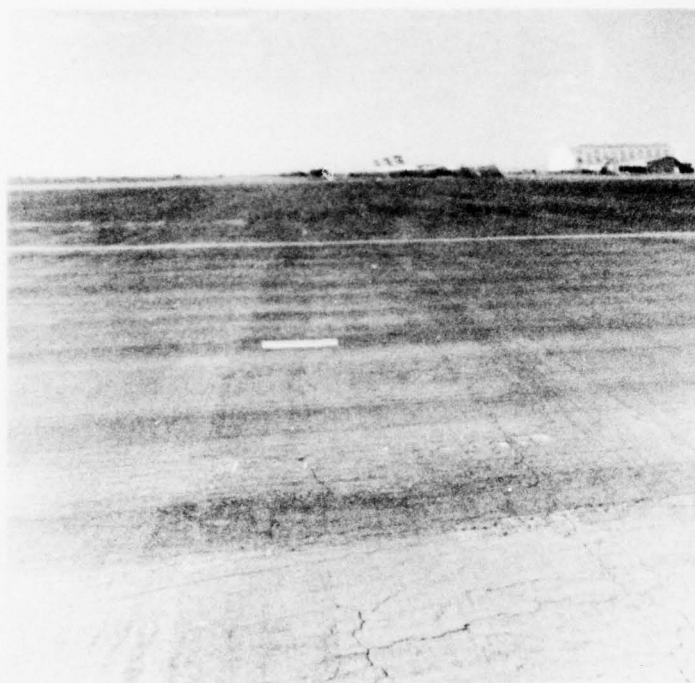
17. The asphaltic concrete (AC) portion of the runway on both sides of the 75-ft keel section was rated as being in good condition, even though there was some cracking. The AC area adjacent to the center wing parking apron and south of taxiway 2 was rated as being in poor condition due to cracking and rutting (photos 5 and 6). This area is scheduled for replacement in the near future. The remaining pavement features not specifically mentioned above were rated as being in good to excellent condition.

Photo 5. Cracking and rutting of AC pavement, south of taxiway 2 and adjacent to center wing parking apron

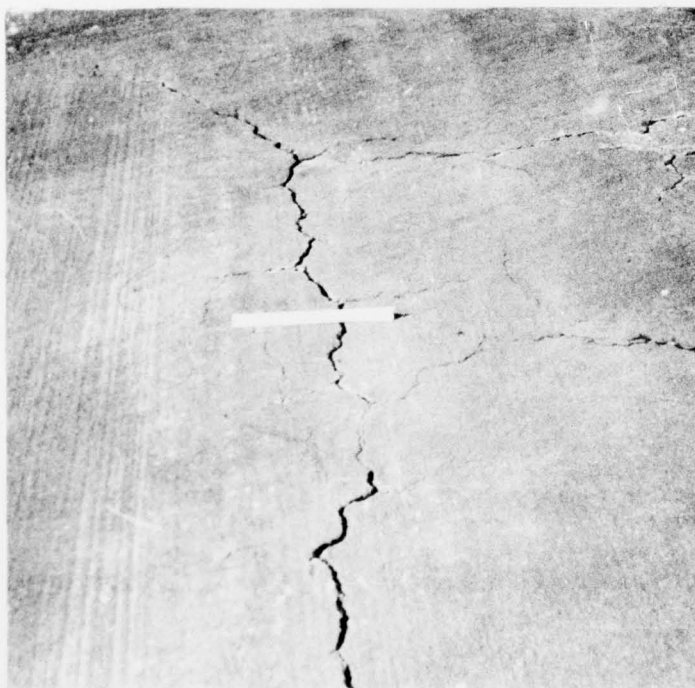
Photo 6. Cracking and rutting of AC pavement, south of taxiway 2 and adjacent to center wing parking apron
